**MALAD WALL
COLLAPSE:
A STATE INDUCED
DISASTER**

*Interim findings of the
joint Fact Finding Team on
the collapse of the MCGM
wall and loss of lives,
homes of residents of
Pimpripada and Ambedkar
Nagar in Malad East,
Mumbai*

*A Joint report by Civil Society
Organisations, Volunteers &
Independent Experts*

10th July 2019

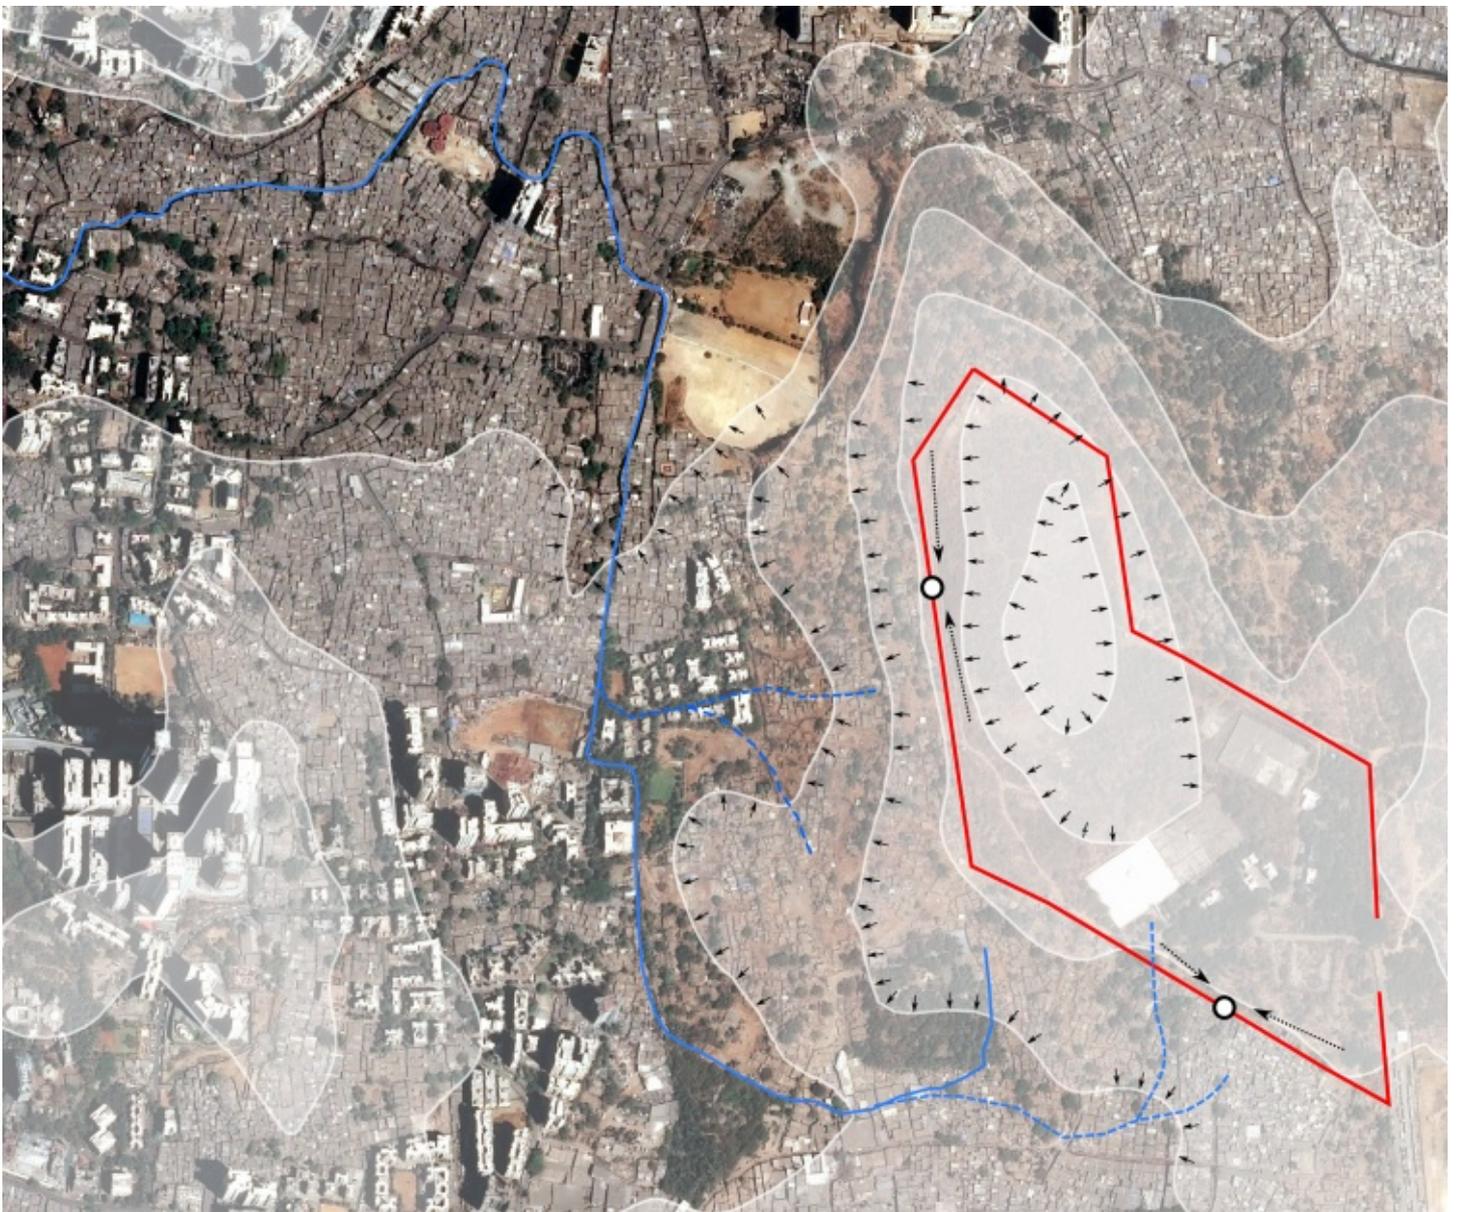
The MCGM's water reservoir facility is located on a hill approximately between 70 to 80 meters above Mean Sea Level, and the settlement of Pimripada and Ambedkar Nagar lie downhill from the facility, on a slope between 60 to 30 meters. At the lowest end of the settlement lies a natural drain, that goes around the hill, moves north to south along through the settlement, and then turns west to eventually join the Malad Creek.

The diagram [pg.13] above shows the topography of the site (10 meter contour intervals), the alignment of the boundary

wall (red line) and the existing drains on site (blue lines). The direction of the natural flow of water is indicated by the small arrows. A narrow road abuts and runs along the length of the wall inside of the plot. The location of the two points where the wall breached are indicated by the black circle. During our visit to the affected site, we observed that the road abutting the wall sloped on both sides towards the point where the wall breached (shown in dotted arrows). This led to the runoff water collecting behind the wall exerting pressure which it wasn't designed to withstand.

During the rain, the storm runoff due to the topography of the site was blocked by the constructed boundary wall, and the existing drainage outlets proved quite insufficient. The wall built around the reservoir was meant to be a visual and physical barrier, not a retaining wall. The difference between a retaining wall and a compound wall is that unlike the former, the latter is not designed to resist lateral pressure of the soil when the ground level is changed on different sides of the wall.

To make matters worse, the wall was poorly designed, in that it did not have any outlets or holes to allow surface runoff - which would have released the pressure of water that logged behind it. The only outlet for water was a culvert under the asphalt, which was most likely clogged by the vegetation that was washed away and carried by the flow. Finally, the water that percolated into the soil where the water logging took place, softening the soil below the asphalt, that in turn ended up weakening the foundation and pressuring the wall even more.

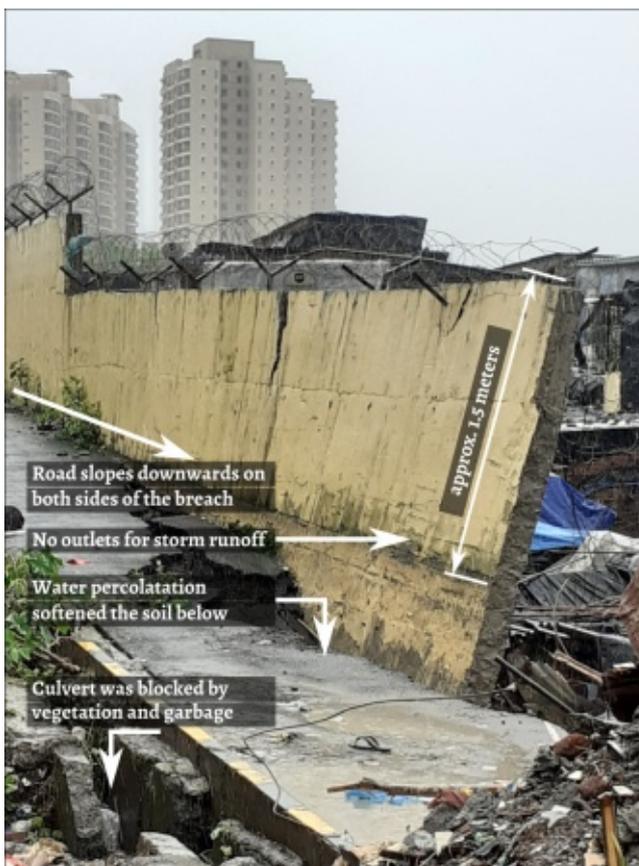
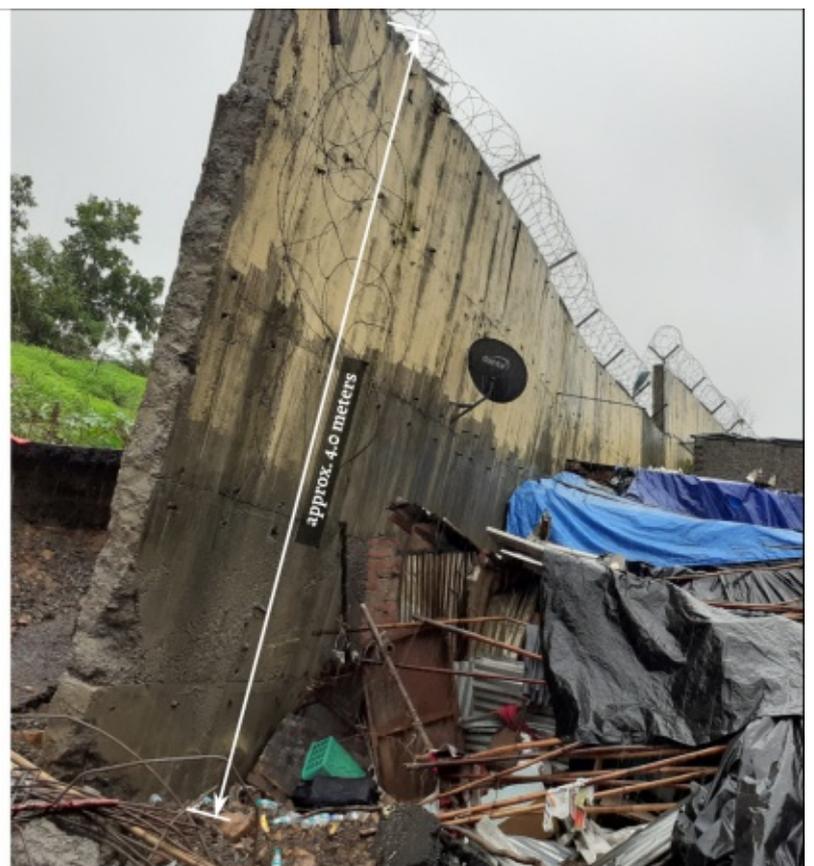
On examination, it emerges that the wall was built without taking into consideration the topography of the site, and the extent of storm runoff and drainage during heavy rain. To build a road on the periphery of the reservoir facility, a retaining wall (typically widening at the base with deep foundations) ought to have been constructed, that would withstand the lateral soil pressure. In addition to the culvert, storm water outlets should have been provided at the road level to prevent water logging. If the protection of the

property from informal settlements was the purpose of the wall, a mesh wire fence mounted on a retaining wall would have served both purposes (allowing road construction as well as protecting the property).
